4.0 PHIL'S AUTO SITE – 701 ISLETA BOULEVARD, SW NMED Facility Number 5517001

4.1 INTRODUCTION/SITE HISTORY

Soil and Groundwater Quality Summary Map

Phil's Auto Site
701 Isleta Blvd., SW
Albuquerque, New Mexico

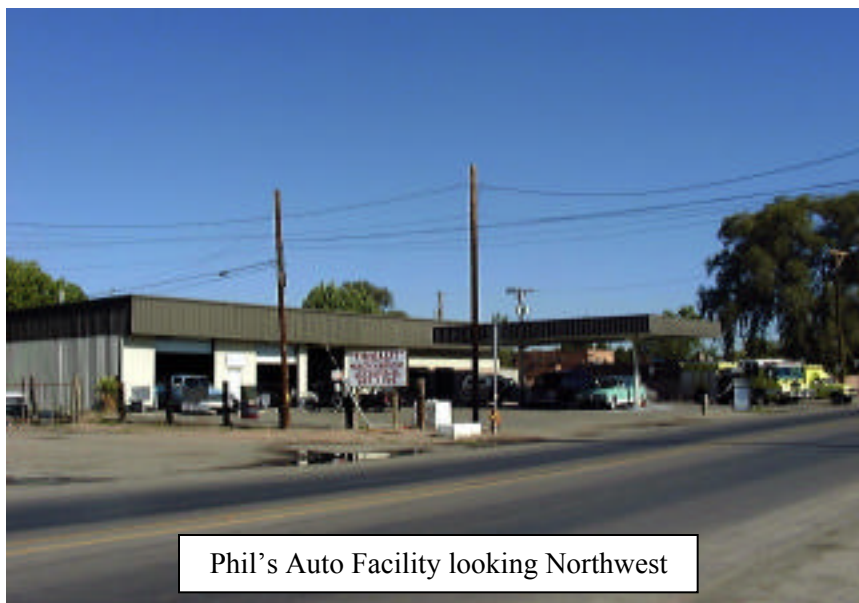
Phil's Auto Facility looking Northwest

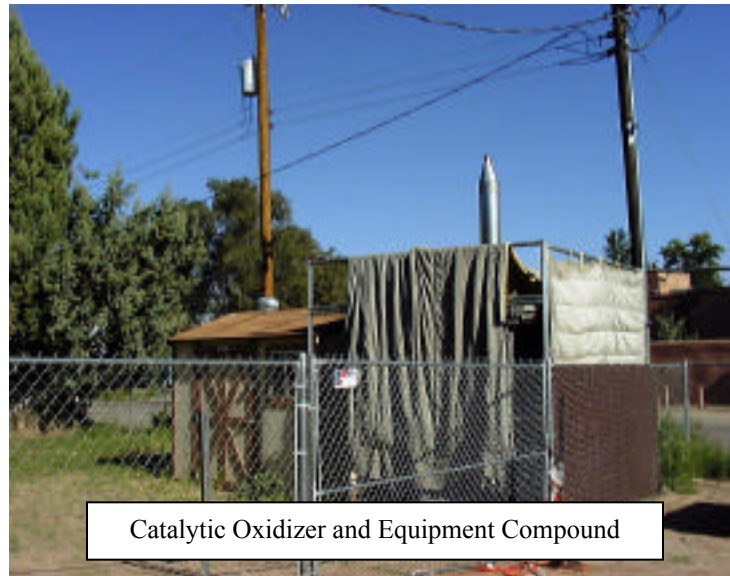
- During our recent site inspection, above ground treatment equipment appeared to be in good condition. The majority of the monitor wells observed at the Site also appeared to be in good condition, with the exception of MW-8, which was reported as destroyed during reclamation system installation. Off-site downgradient wells were not inspected due to site access restrictions.

Catalytic Oxidizer and Equipment Compound

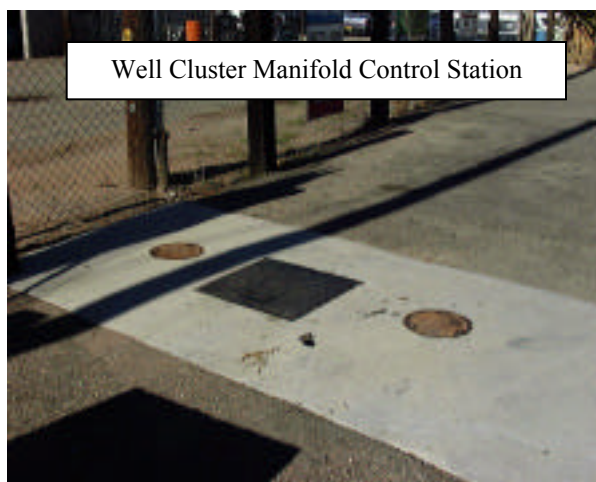
- The current monitor well network is inadequate to define the magnitude and extent of remaining ground water contaminants.
- Remedial design of the treatment system does not allow for individual operation of well nests. Instead, three manifold well boxes (see photograph next page; Figure 4A) are located at the Site which allow adjustment of groups of wells. This type of arrangement often leads to the creation of "dead zones" in the subsurface between treatment wells where little or no remediation has occurred.

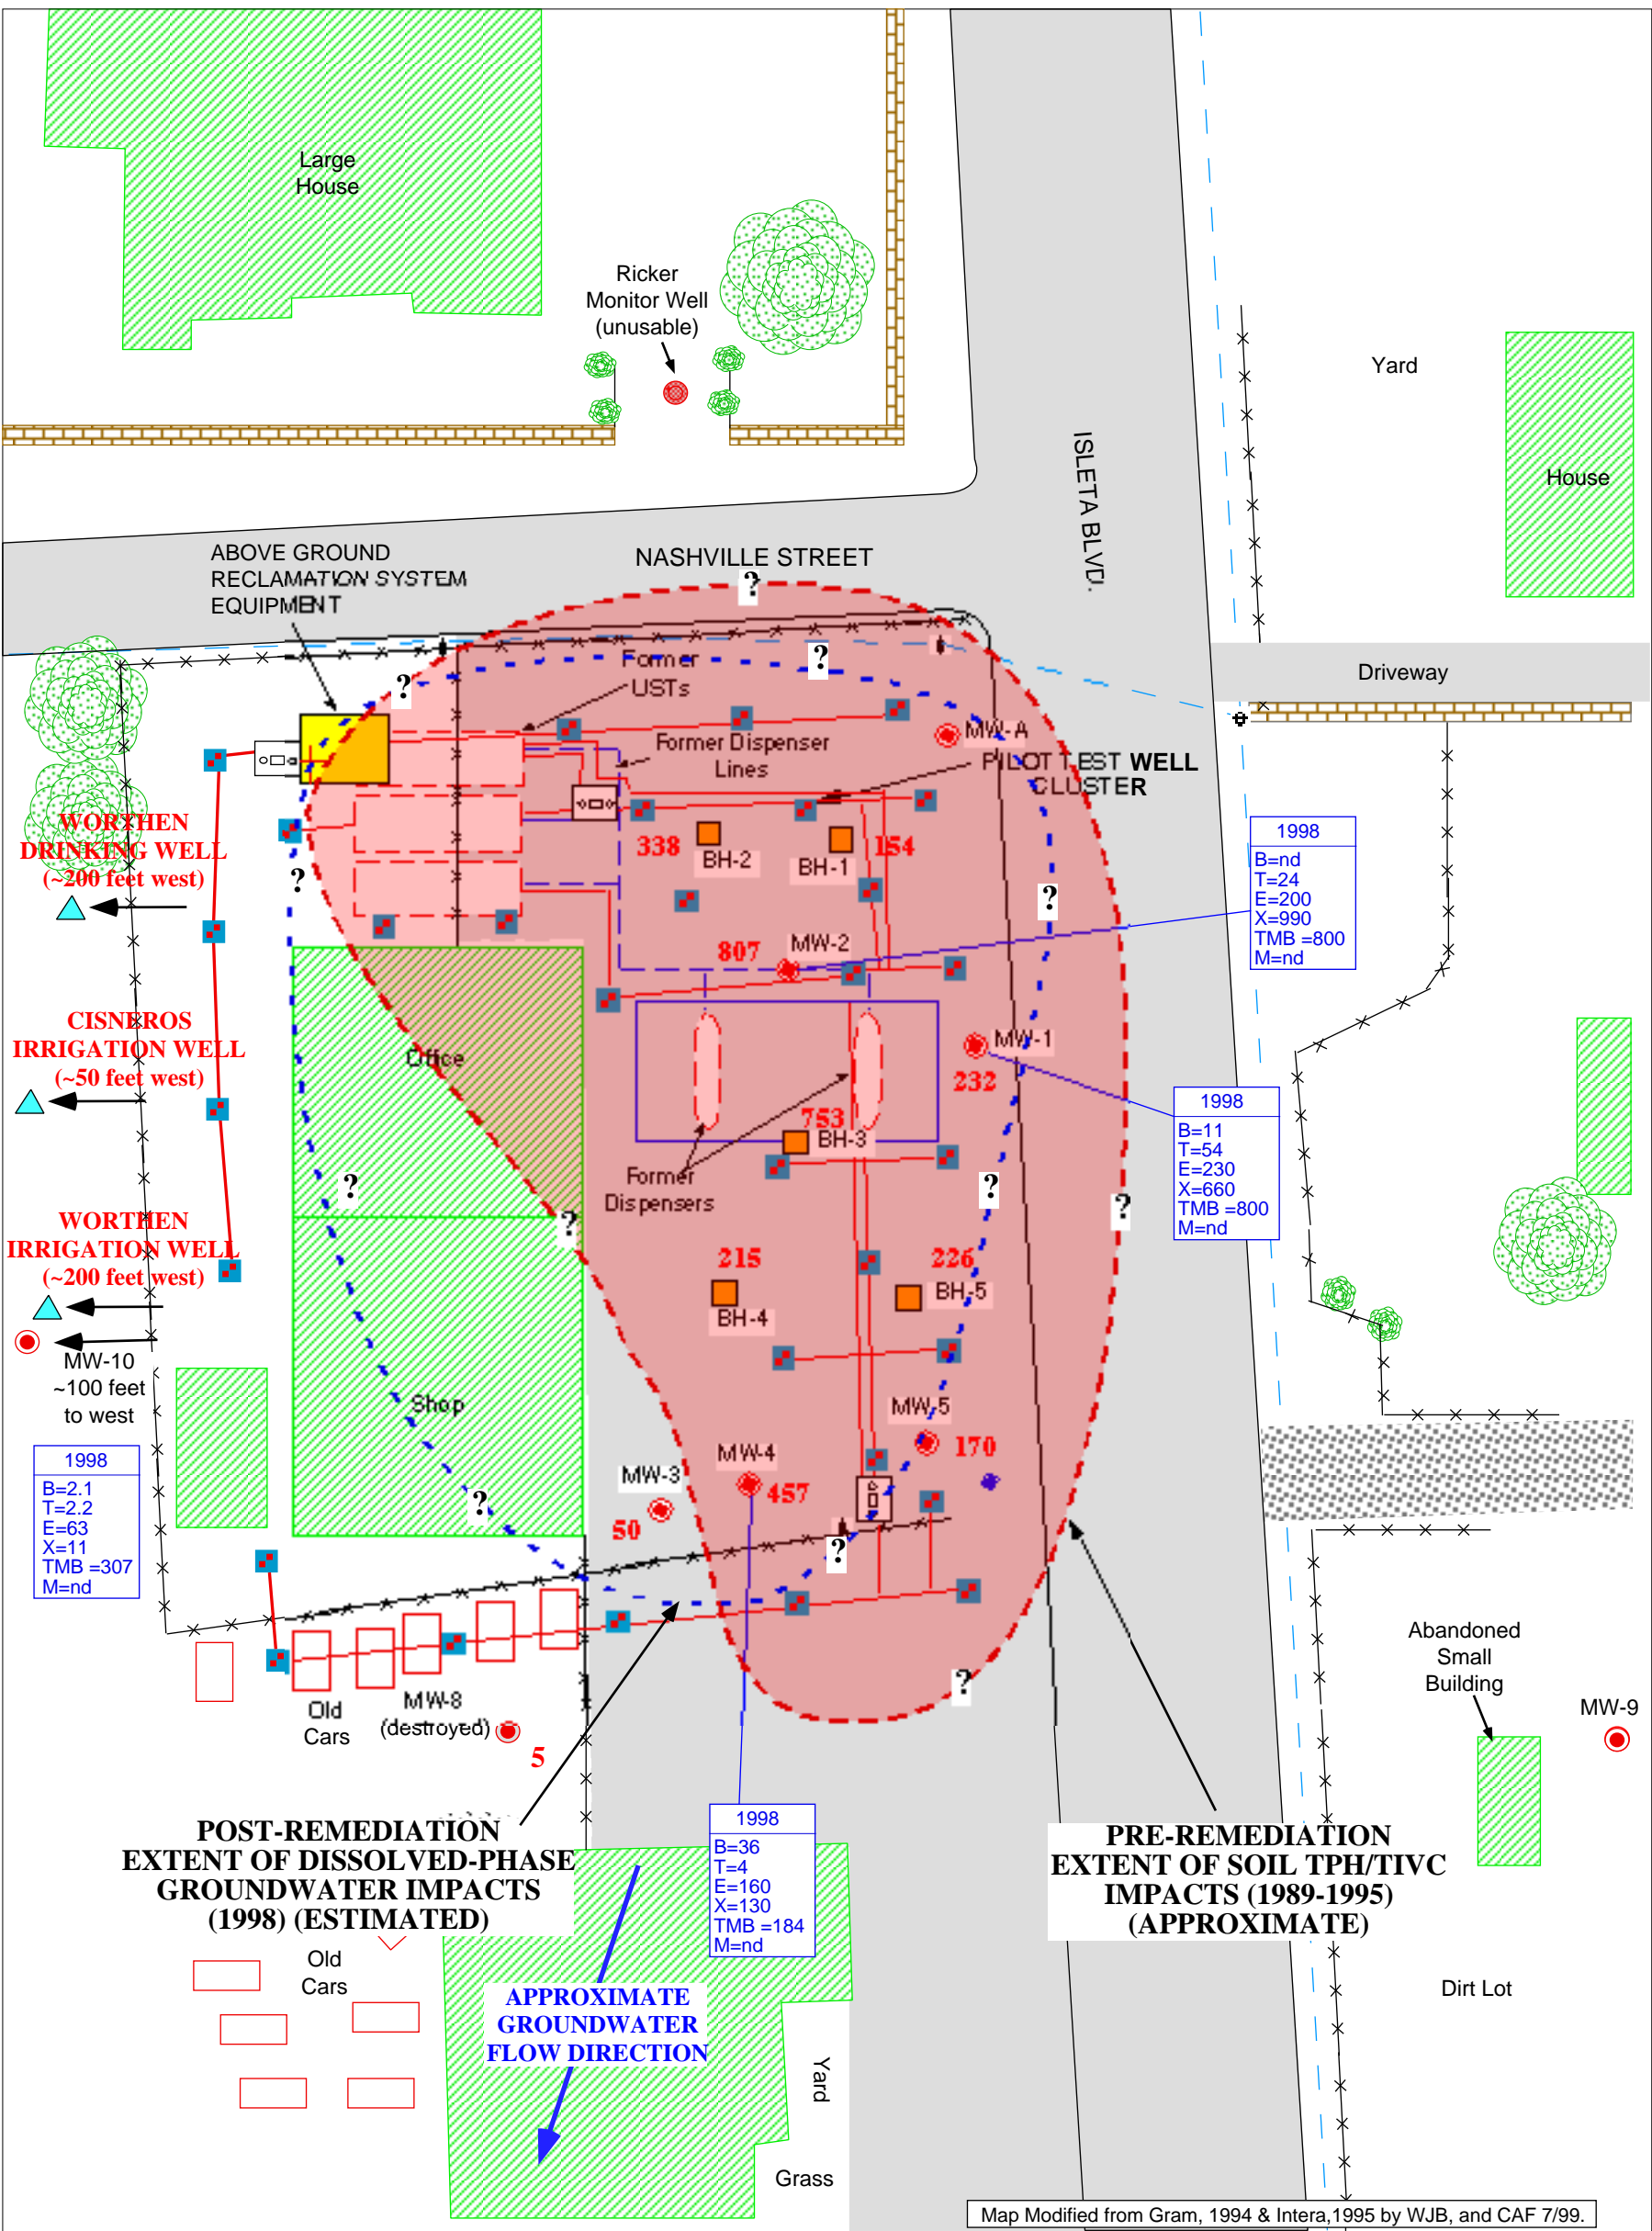
Drawn by:	WJB	7/99	Client: BCEHD
Drafted by:	ABL	7/99	Job # 035-001
Reviewed by:	WJB	7/99	Figure: 4A

- The Site was used to dispense fuel for several decades. Based on available site data, three USTs containing gasoline were formerly located along the northern side of the property (Figure 4A). Analysis of inventory records indicated a cumulative loss of over 8,500 gallons from the unleaded and regular UST systems. These tanks were removed from the ground in October 1993.

- The approximate extent of soil hydrocarbon contamination prior to remedial efforts is shown in Figure 4A. TPH soil contamination was likely concentrated in the central and northern vicinity of the Site. Analysis of laboratory chromatograms suggests gasoline contaminants at the Site were weathered in nature. A larger diameter vapor-phase hydrocarbon zone likely surrounds the TPH contamination core.
